Manhole Inspection Summary

Manhole # S19I__042MH

Insp Date: **9/28/07 10:08 AM**

Location Address: **33 PULASKI ST**

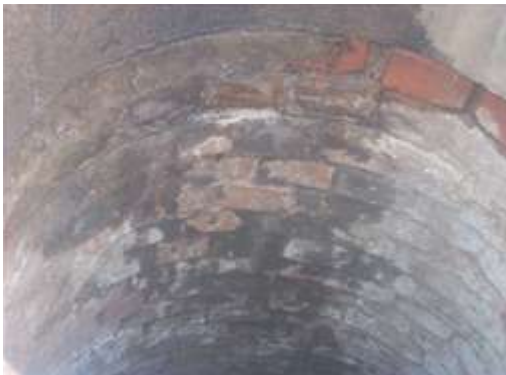
Defect 3

Infiltration: ☐ None ☐ Joint ☐ Cracks ☐ Mortar ☐ Roots ☒ **Wall**

CHIMNEY INFILTRATION

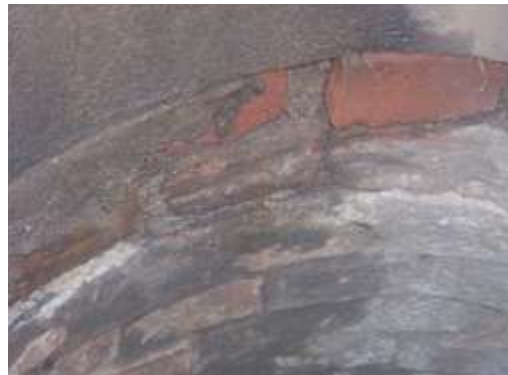
Defect 2

Condition: ☐ Sound ☒ **Cracked** ☐ Root Intrusion ☐ Loose Brick ☒ **Deteriorated**

CHIMNEY DETERIORATION

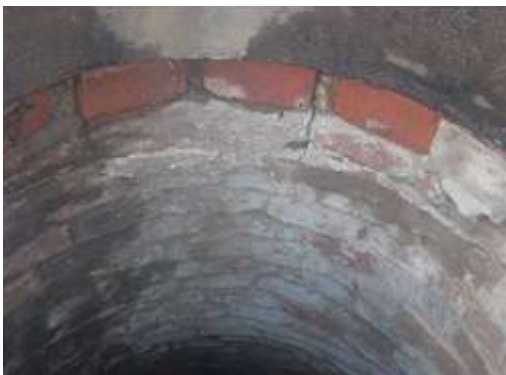
Defect 1

Condition: ☐ Sound ☒ **Cracked** ☐ Root Intrusion ☐ Loose Brick ☐ Deteriorated

CRACKED CHIMNEY AND CORBEL

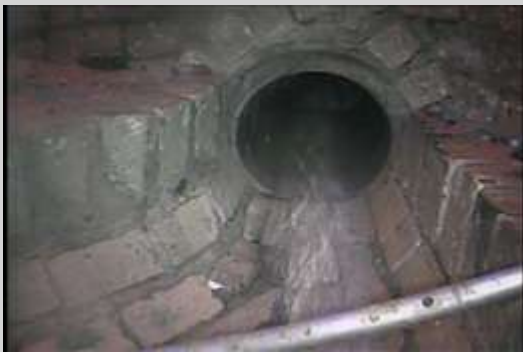
12 O'Clock Outflow

8 in. Circular Gravity Sewer
Pipe Out @ 12 O'Clock

Pipe Height: **8.4** (in.) Rod and Bar (Angled)
Pipe Material: **Clay** ☐ Pipe Lined
Invert Depth: **9.66** (ft.) Flow Characteristics: **Slow**
Deposits: ☒ None ☐ Mud ☐ Sludge ☐ Debris ☐ Grease
Silt Depth: (in.) Deposits Extent:
Infiltration: **None** Pipe Seal Cond: **Sound**

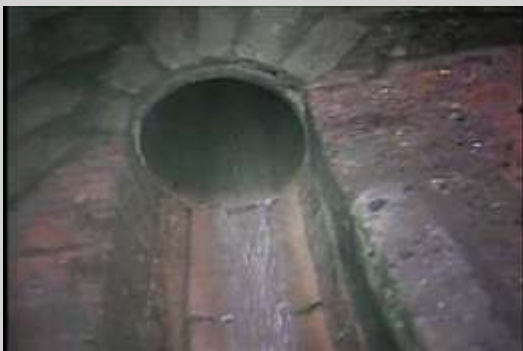
6 O'Clock Inflow

8 in. Circular Gravity Sewer
Pipe In @ 6 O'Clock

Pipe Height: **8.4** (in.) Rod and Bar (Angled)
Pipe Material: **Clay** ☐ Pipe Lined
Invert Depth: **9.05** (ft.) Flow Characteristics: **Slow**
Deposits: ☒ None ☐ Mud ☐ Sludge ☐ Debris ☐ Grease
Silt Depth: (in.) Deposits Extent:
Infiltration: **None** Pipe Seal Cond: **Sound**

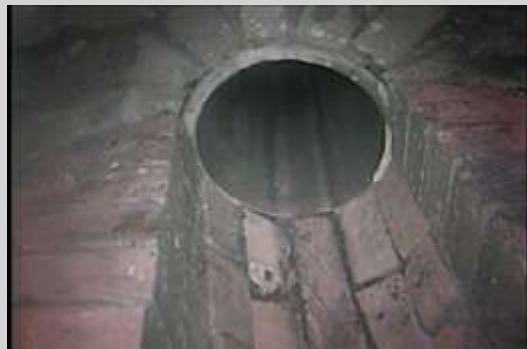
9 O'Clock Inflow

8 in. Circular Gravity Sewer
Pipe In @ 9 O'Clock

Pipe Height: **8.4** (in.) Rod and Bar (Angled)

Invert Depth: **8.94** (ft.) Flow Characteristics: **Slow**

Infiltration: **None**

Pipe Seal Cond: **Sound**
